Aerial Survey of the Deschutes River, Washington

Thermal Infrared and Color Videography

February 3, 2003

Final Report

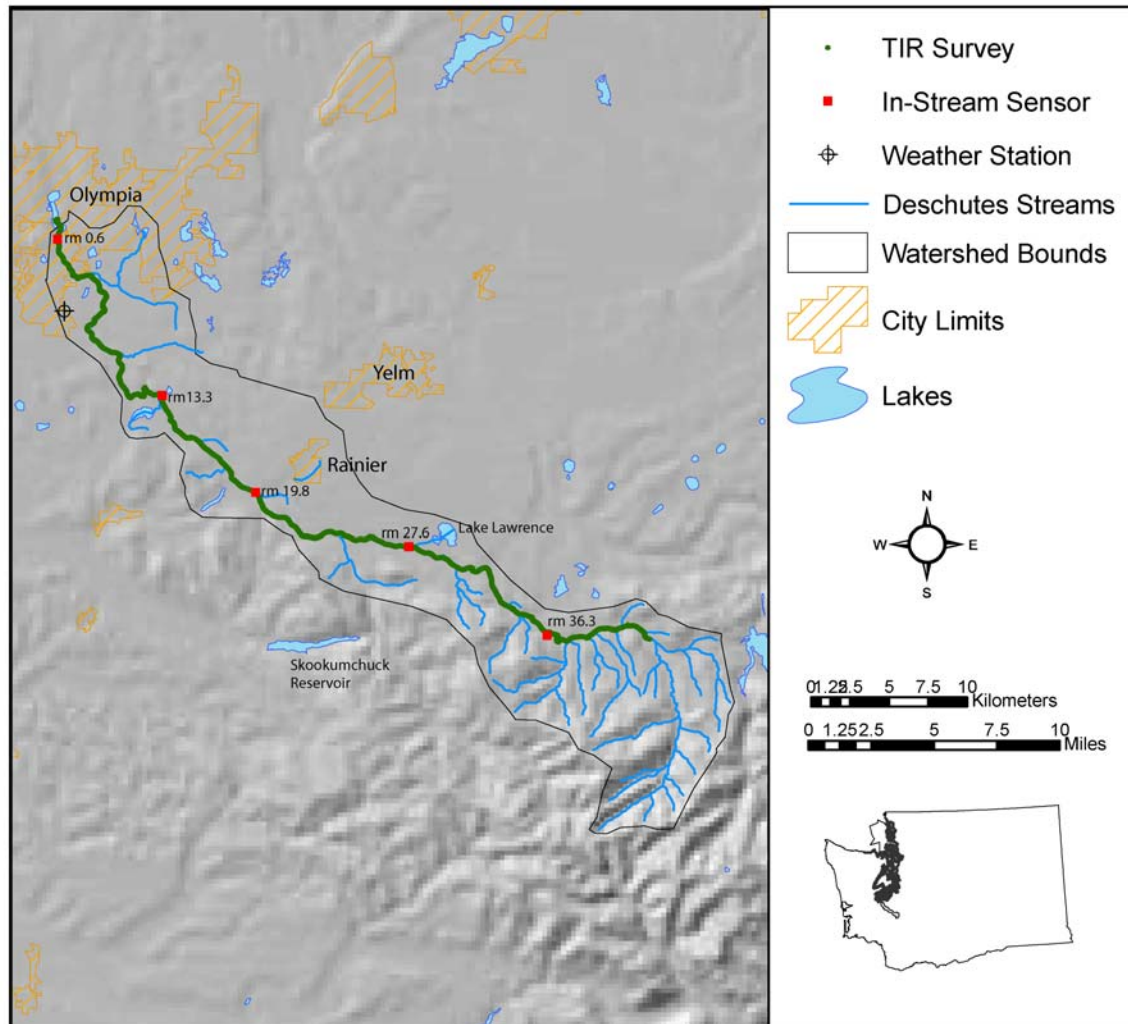
Figure 1 – Map showing the extent of the airborne TIR on the Deschutes River. The plot shows the location of the portable weather station and the location of in-stream sensors used to ground truth radiant temperatures derived from TIR images labeled by river mile (rm).

The airborne survey of the Deschutes River was conducted on the afternoon of August 19, 2003. The river was flown upstream from Capitol Lake to Deschutes Falls, a distance of 42 miles (Figure 1).

Prior to the flight, WS, LLC deployed in-stream data loggers in order verify the accuracy of the TIR data (i.e. ground truth). The in-stream data loggers were ideally located at intervals of 10 river miles or less over the survey route. Meteorological data including air temperature and relative humidity were recorded using a portable weather station (*Onset*) located at the Olympia Airport.

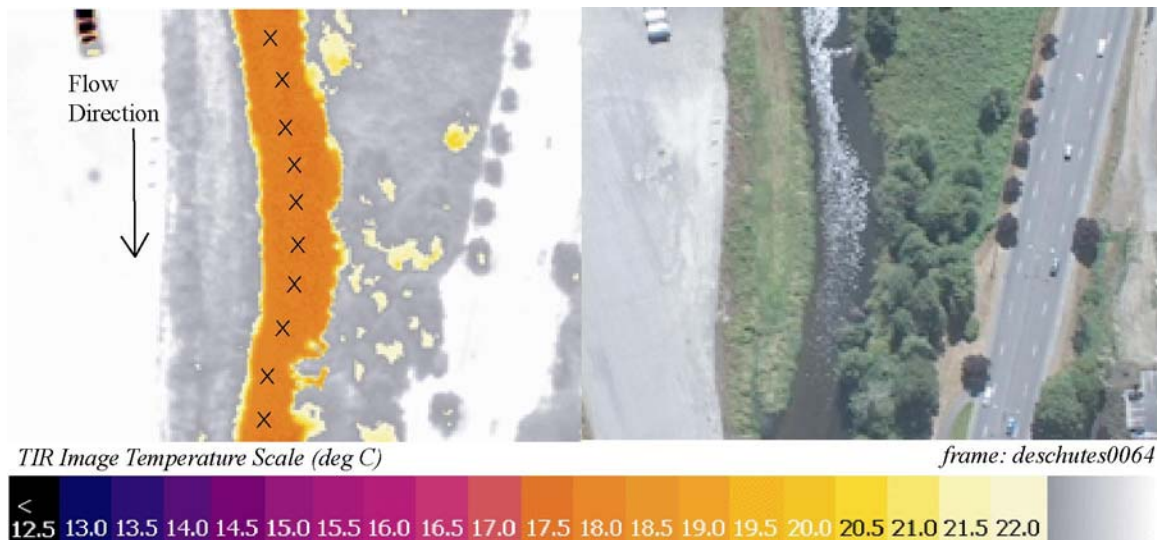
Figure 2 – TIR/color video image pair showing how temperatures are sampled from the TIR images. The black X's on the TIR image show typical sampling locations near the center of the stream channel. The recorded temperature for this image is the median of the sample points.

Once the TIR images were calibrated, they were integrated into a GIS in which an analyst interpreted and sampled stream temperatures. Sampling consisted of querying radiant temperatures (pixel values) from the center of the stream channel and saving the median value of a ten-point sample to a GIS database file (Figure 2). The temperatures of detectable surface inflows (i.e. surface springs, tributaries) were also sampled at their mouth. In addition, data processing focused on interpreting spatial variations in surface temperatures observed in the images. The images were assigned a river mile based on a 1:100k routed GIS stream coverage from the Environmental Protection Agency (*Note: measures assigned from this coverage may not match stream measures derived from other map sources*).

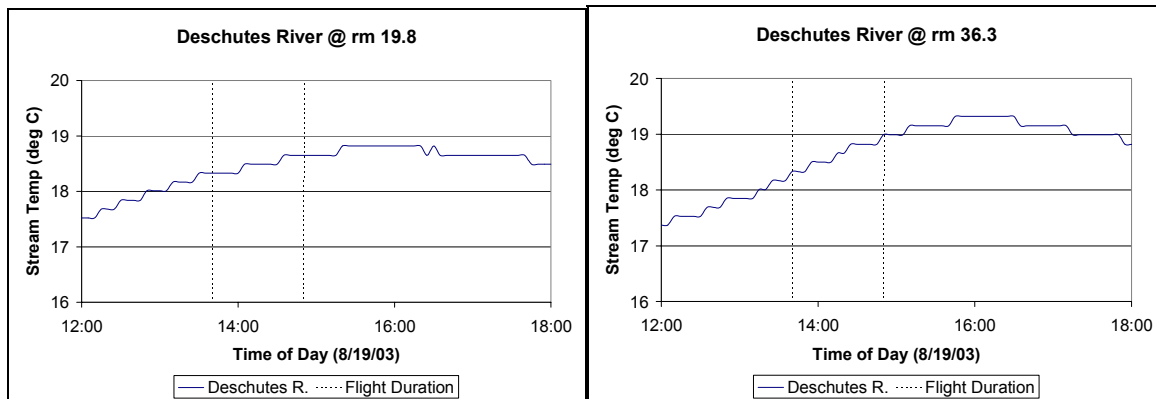
Figure 3 – Diurnal stream temperature variation during the afternoon of the TIR survey measured at two monitoring sites. The plots show the variations in relation to the time of the flight.

Figure 3 shows continuous in-stream temperature measurements in relation to the time of the TIR survey for two monitoring locations. Although not comprehensive, the plots provide some measure of when the TIR flight occurred in relation to the daily stream temperature maximum and provides a measure of temperature changes that occur during the time span of the flight. As shown, the flight was conducted just prior to the daily stream temperature maximums, which occurred between 15:25 and 16:15 at river mile 19.8 and between 15:50 and 16:23 at river mile 36.3. Water temperatures increased by 0.4°C during the course of the flight at river mile 19.8 and increased by 0.7°C at river mile 36.3. The influence of water temperature changes during the course of the flight is addressed in more detail in the *Discussion* section of this report.

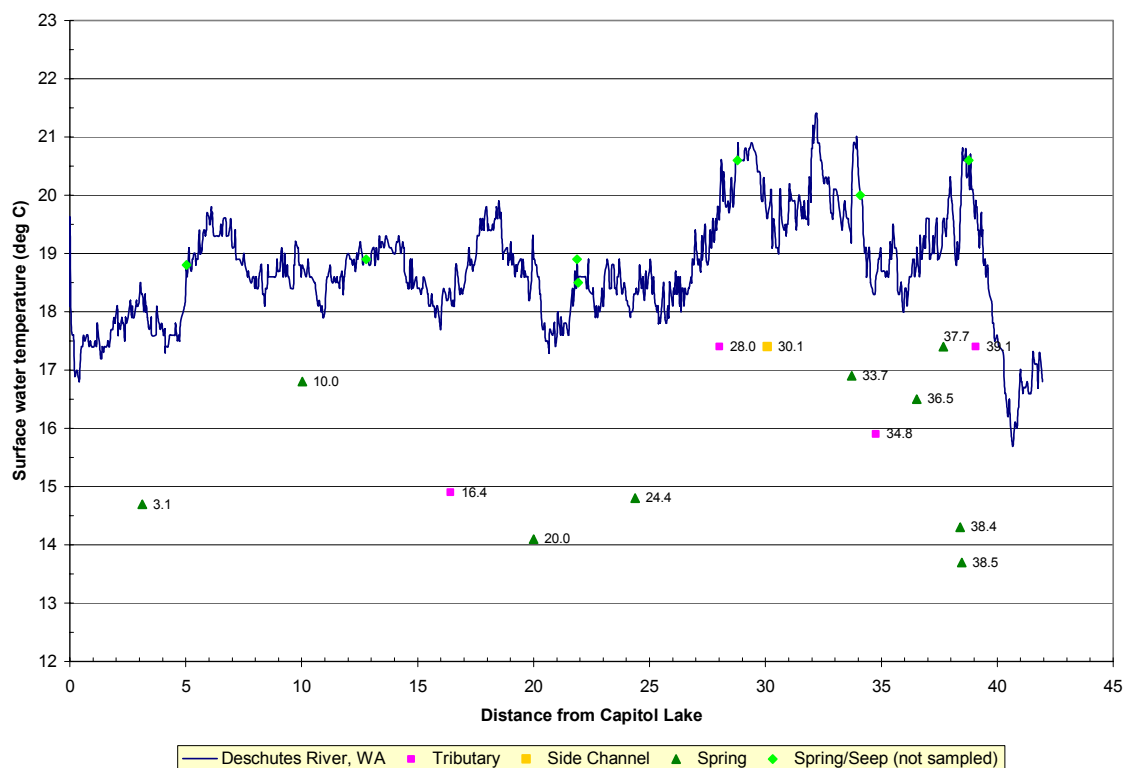
Figure 4 – Median stream temperatures plotted versus river mile for the Deschutes River, WA on August 19, 2003. The location of each surface water inflow is indicated by river mile.

Median radiant temperatures were plotted versus river mile for the Deschutes River, WA (Figure 4). The location and name of sampled tributaries are illustrated on the plot by river mile and are listed in Table 3. Numerous apparent springs or small cool water seeps were detected while sampling temperatures along the Deschutes River. Several of these were not sampled for temperature due either to their small size or because they could not be positively identified in the imagery due to visible shadowing or vegetation. In order to facilitate visual interpretation of the spatial patterns, the location of these detected, but not sampled, cool areas were also plotted on the longitudinal temperature profile using the same temperature as the main stem. The longitudinal profile was also plotted in relation to in-stream temperatures both at the time of the over flight and the maximum daily temperature (Figure 5). At some locations, the data logger was retrieved prior to recording the daily maximum temperature and the in-stream temperature at the time of retrieval was plotted in lieu of the maximum temperature.

Overall, the Deschutes River exhibited a high degree of spatial thermal variability across multiple spatial scales. Visual inspection of the longitudinal temperature profile shows patterns of warming and cooling occurring at the reach and sub-reach scales. Four tributaries were sampled over the 42-mile survey extent and each contributed cooler water to the main stem. A total of 9 sub-surface inflows were sampled with an additional 8 suspected springs (or seeps) detected, but not sampled. The contribution of these cool water sources in defining spatial stream temperature patterns were often directly evident from the imagery. However, the detection of the sub-surface exchanges also provides an indication of the hydrologic processes (e.g. hyporheic flow) that are defining spatial temperature patterns at a broader scale.

At the upstream end of the survey, stream temperatures increased rapidly from $\approx 15.7^{\circ}\text{C}$ at river mile 40.7 to $\approx 20.6^{\circ}\text{C}$ at river mile 38.8. Radiant water temperatures declined over the next 2.8 miles reaching 18.0°C at river mile 36.0. Five inflows were detected through this reach, which contributed to the overall cooling trend. The localized thermal response from the two springs at river miles 38.4 and 38.5 is clearly apparent in the profile. Moving downstream, the profile shows a general warming trend with a relatively high degree of local variability. Local temperature maximums of 21.0°C and 21.4°C were observed at river miles 33.9 and 32.2 respectively. Both of these peaks were followed by rapid cooling. A spring inflow contributed at least in part to the cooling observed at river mile 33.9. However the source of cooling downstream of river mile 32.2 was not directly evident from the imagery. Inspection of the 1:24K topographic base maps shows that the apparent decrease occurs just downstream of the mapped valley of Lackamas Creek.

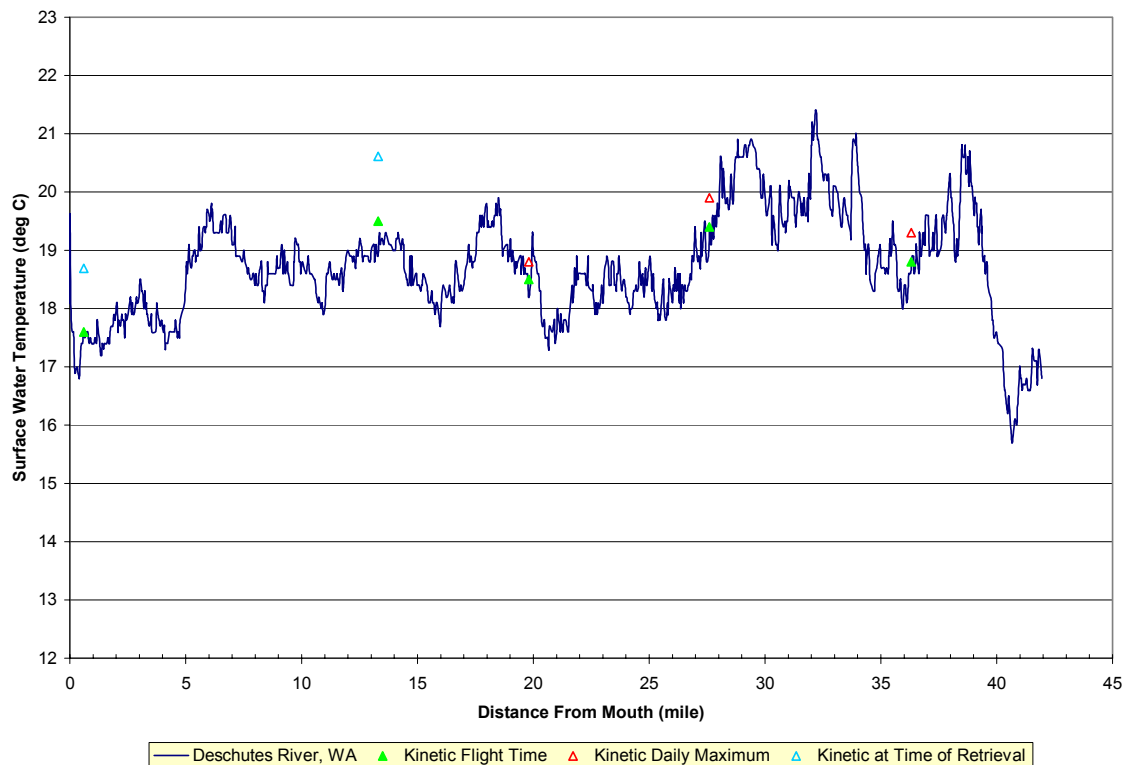
Figure 5 - - Longitudinal temperature profile derived from the TIR data plotted in relation to recorded in-stream (kinetic) temperatures. The temperature at the time the sensor was retrieved was plotted instead of daily maximum temperature at locations where the sensor was retrieved prior to recording the daily maximum temperature.

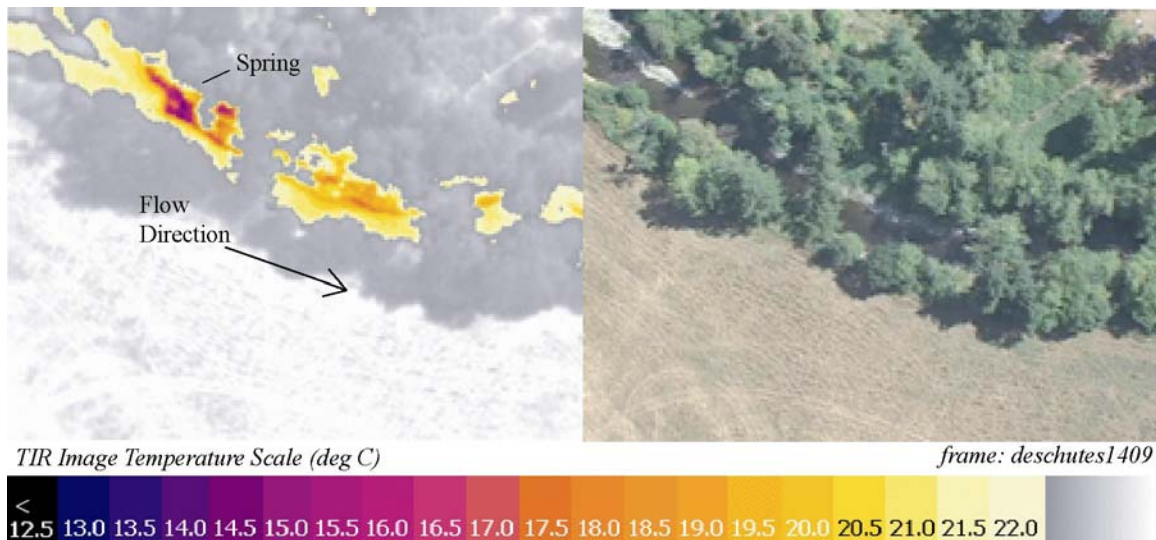
Figure 6 – TIR/color video image showing an apparent spring at river mile 28.8. The spring was not sampled for temperature due to the uncertainty created by the visible shadows. However, the longitudinal profile shows a local decrease in water temperatures downstream of this point.

Between river miles 28.8 and 25.5, water temperatures in the Deschutes River decreased by $\approx 2.7^{\circ}\text{C}$. An apparent spring (not sampled) was detected at the upstream end of this reach and appeared to cool temperatures immediately downstream (Figure 6). However, the steady cooling trend (≈ 3.3 miles) is more indicative of a diffuse cooling source (i.e. shallow sub-surface exchange) throughout the reach or of a broader response to basin morphology than of a point source influence.

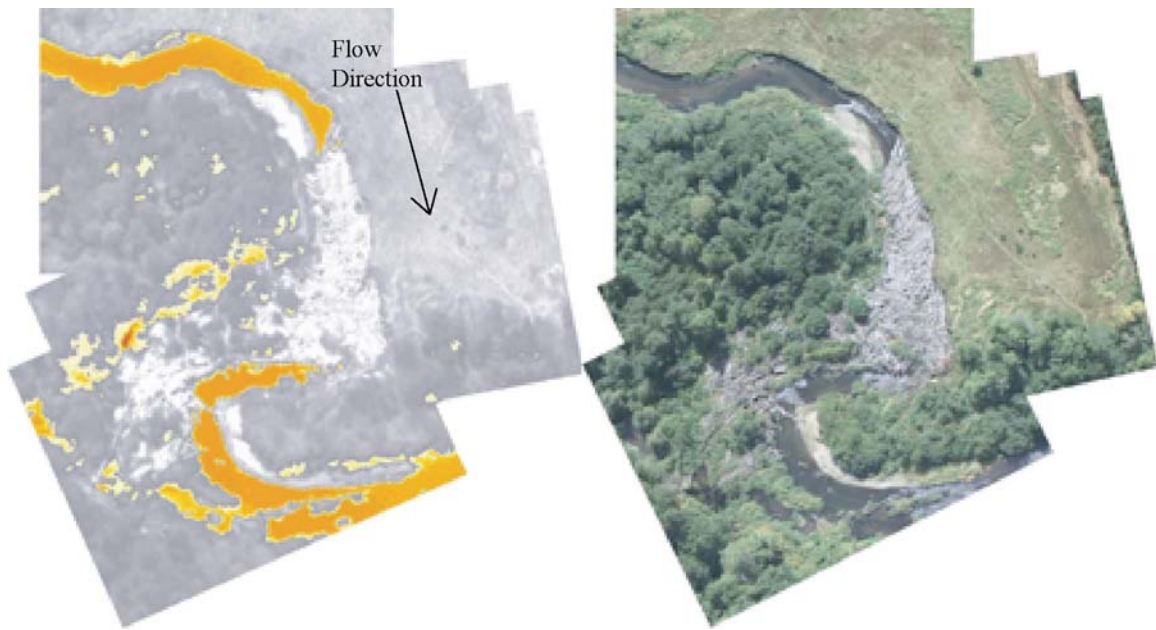
frame: deschutes0265-0271

Figure 7 - TIR/color video image pair showing a log jam at river mile 5.1 of the Deschutes River (18.8°C). A decrease in stream temperatures of $\approx 1.2^{\circ}\text{C}$ was observed within 0.3 miles downstream of the log jam.

A log jam was detected in the Deschutes River at mile 5.3 (Figure 7). Downstream of the log jam stream temperatures decreased from $\approx 18.7^{\circ}\text{C}$ to $\approx 17.7^{\circ}\text{C}$. With the exception of the contribution of an apparent spring (not sampled) detected just downstream of the log jam, the source of cooling at this location was not directly evident from the imagery. One hypothesis might be that the log jam is forcing more water through shallow, sub-surface pathways. However, the actual source of cooling was not apparent from the imagery.

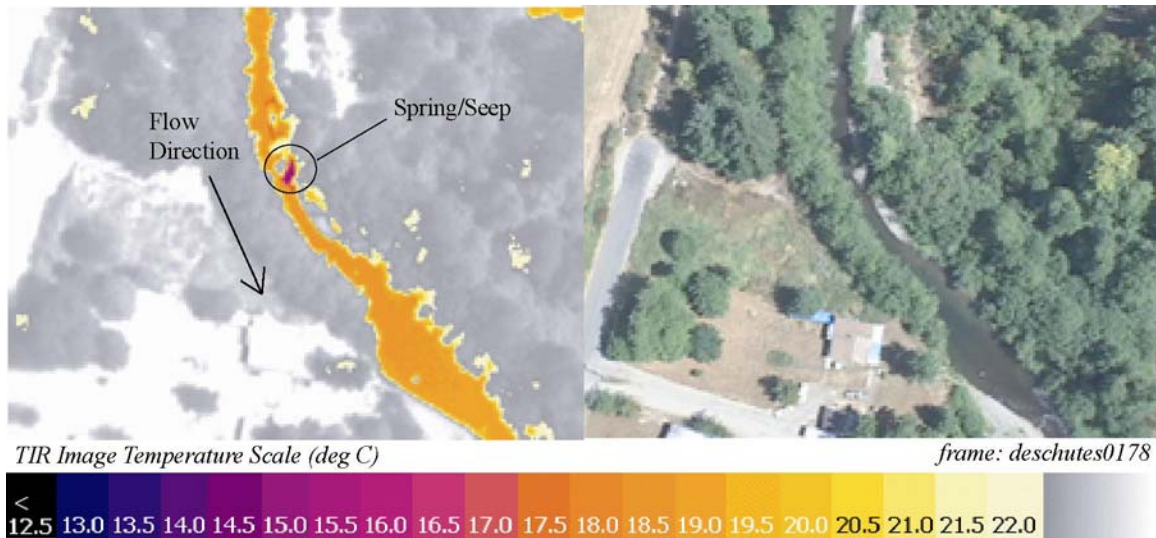
TIR/color video image pair showing an apparent spring/seep (14.7°C) along the left bank of Deschutes River (18.3°C) at river mile 3.1.

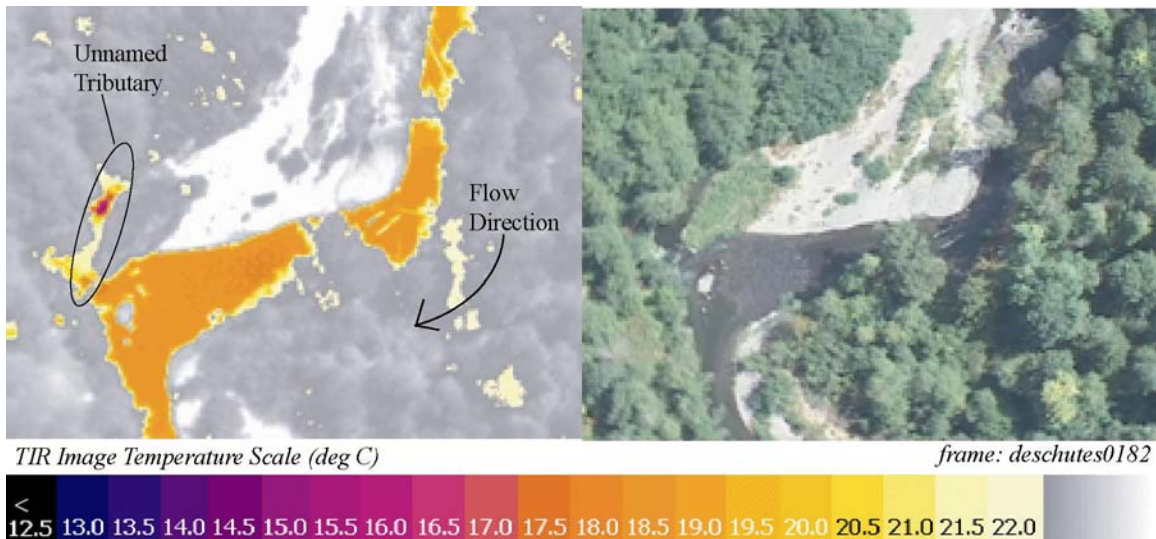
TIR/color video image pair showing an unnamed tributary (unsampled) along the right bank of Deschutes River (18.0°C) at river mile 3.2.

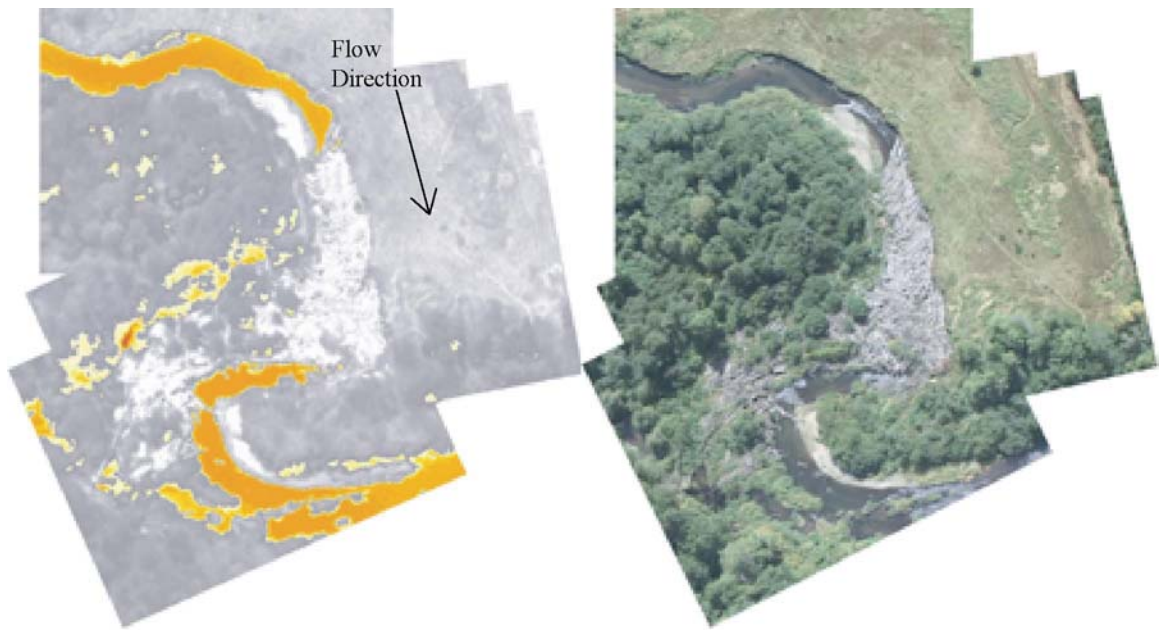
frame: deschutes0265-0271

TIR/color video image pair showing a log jam at river mile 5.1 of the Deschutes River (18.8°C)

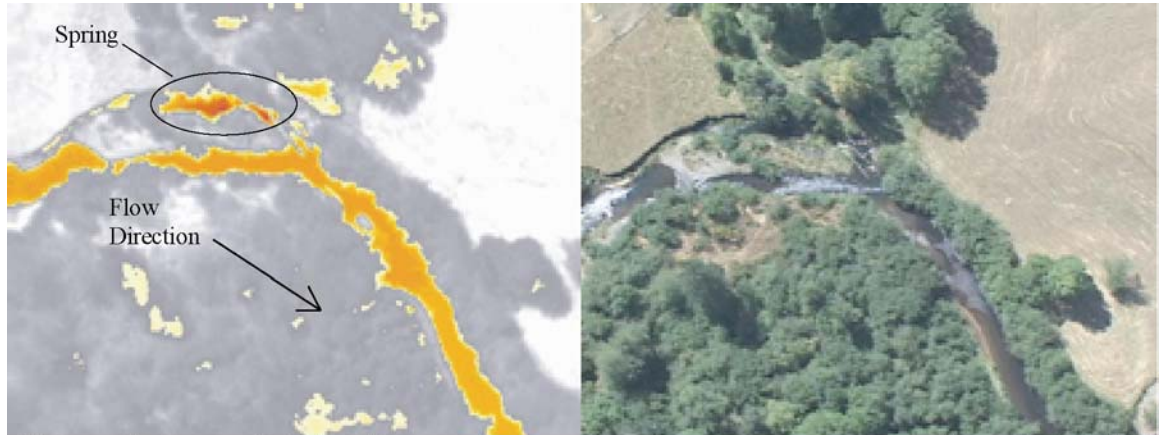
frame: deschutes0524

TIR/color video image pair showing an apparent spring (16.8°C) along the left bank of Deschutes River (187.8°C) at river mile 10.0.

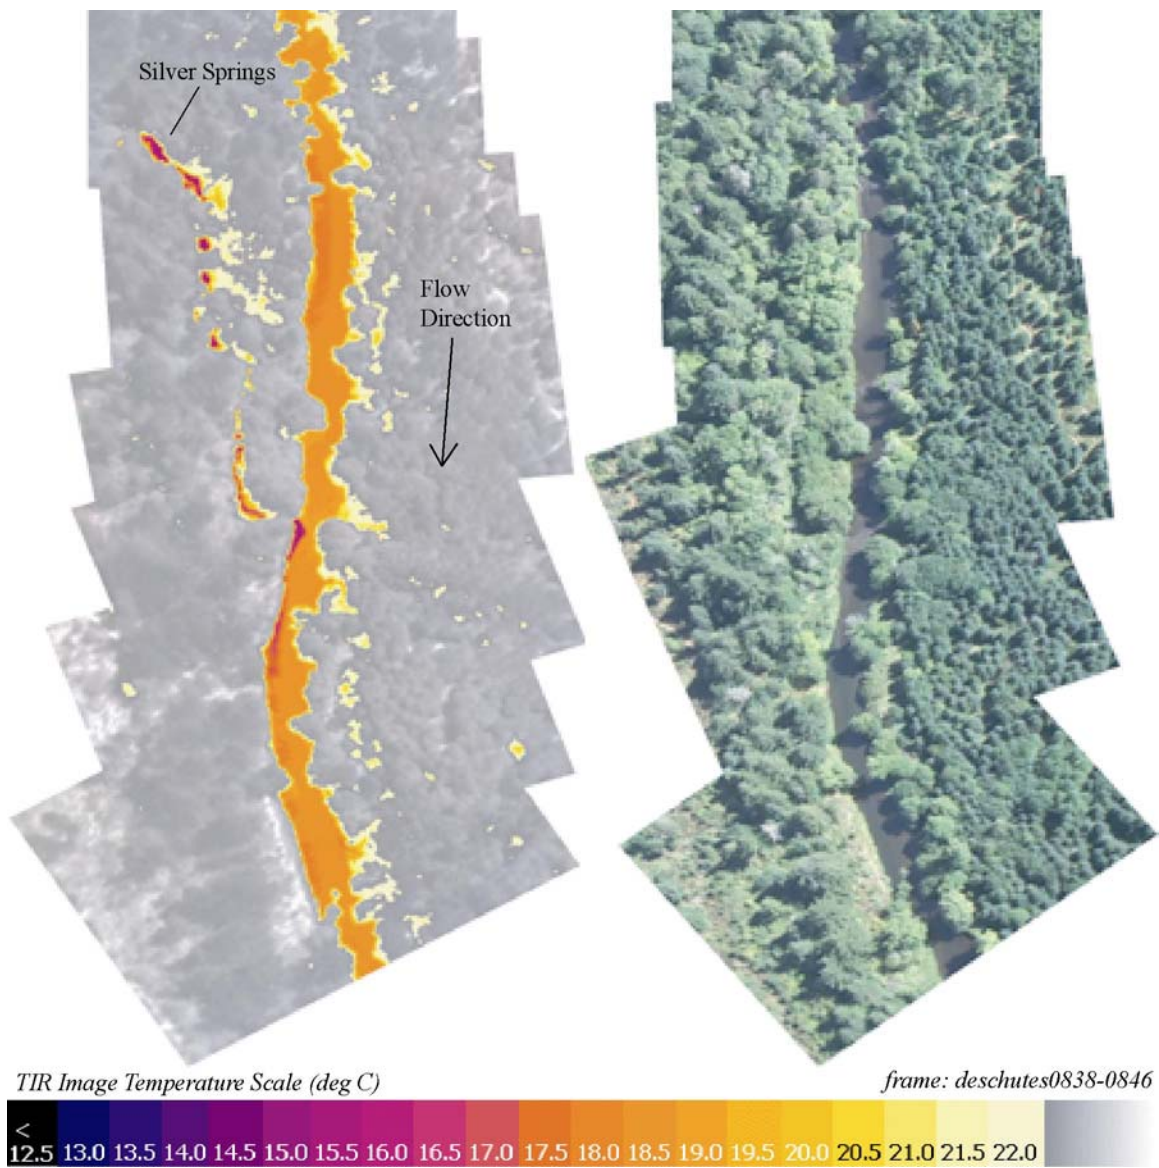
TIR/color video image pair showing the confluence of Silver Springs (14.9°C) to the right bank of Deschutes River (18.3°C) at river mile 16.4.

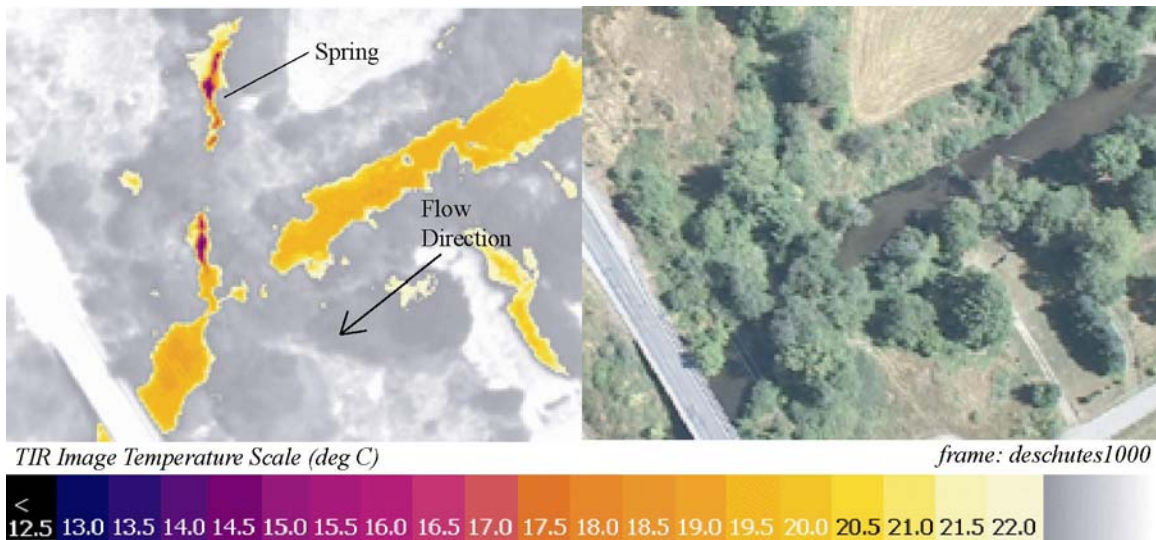
TIR/color video image pair showing a spring (14.1°C) on the right bank of Deschutes River (18.9°C) at river mile 20.0.

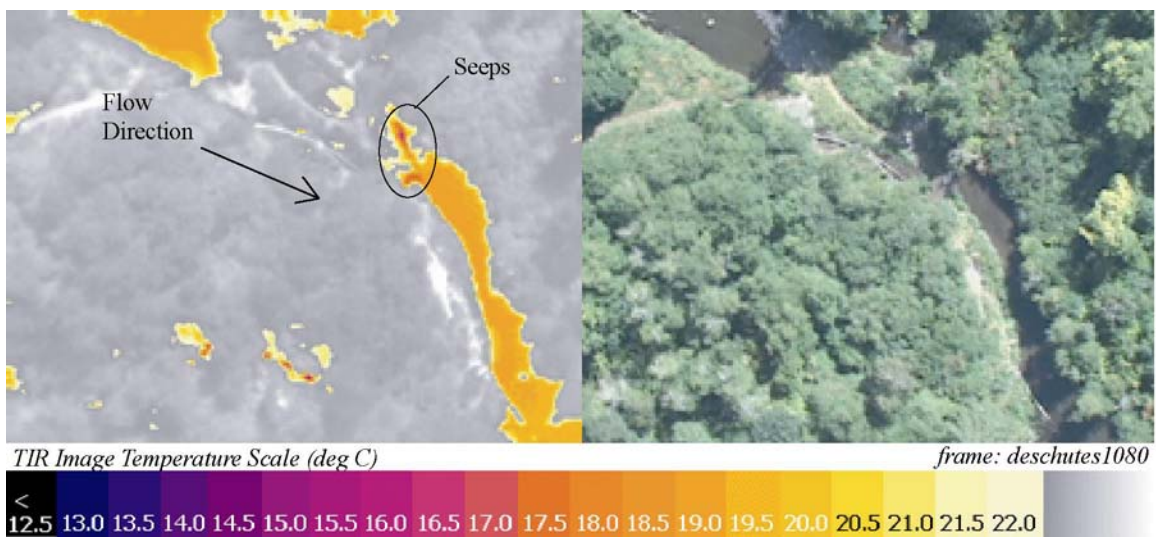
TIR/color video image pair showing two apparent seeps at the bottom of the gravel bar at river mile 21.9 of Deschutes River (18.9°C).

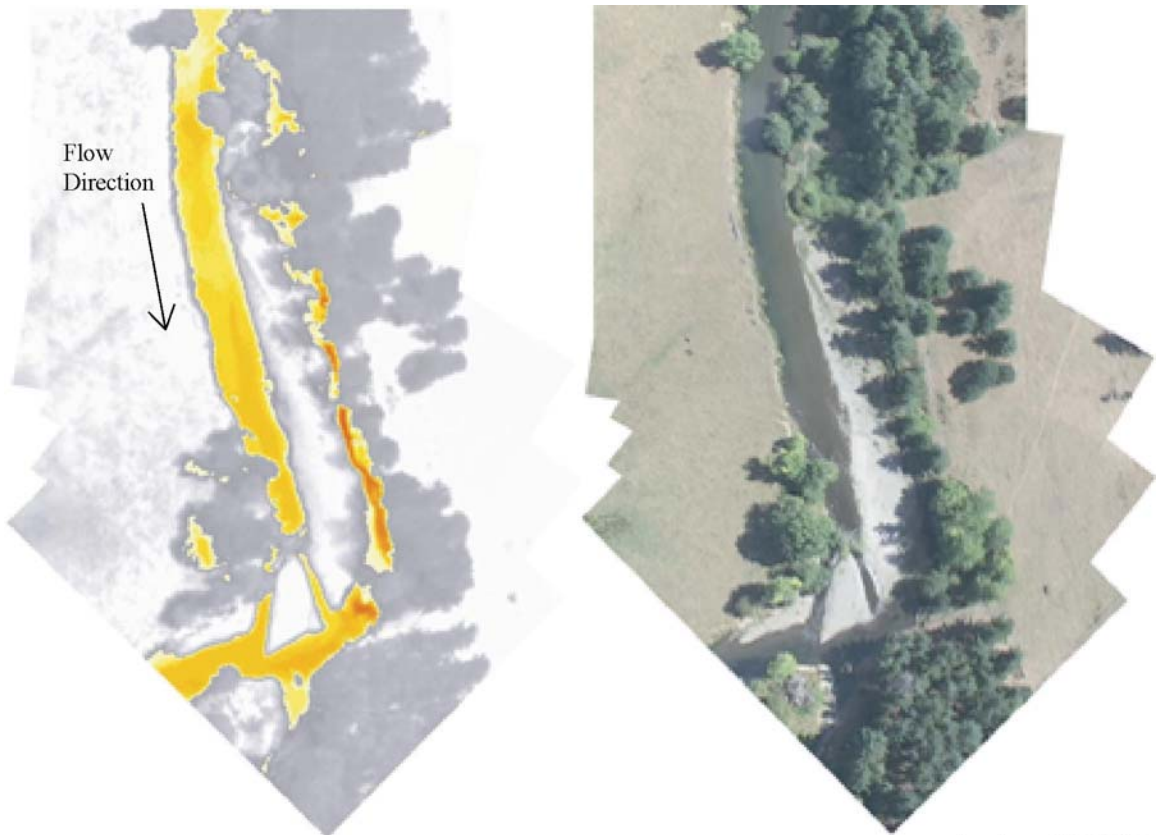
frame: deschutes1461-1465

TIR/color video image pair showing a cool side channel (17.4°C) along the left bank of Deschutes River (19.6°C) at river mile 30.1.

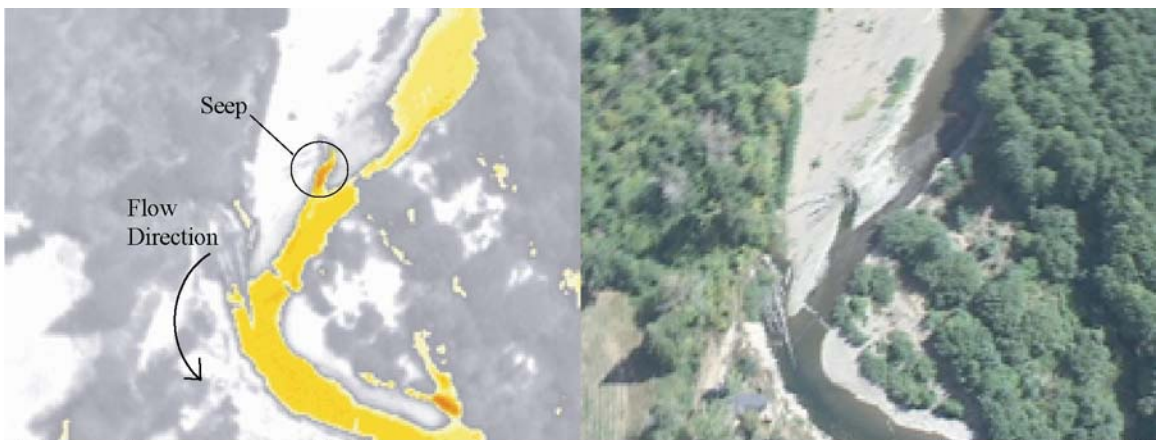
frame: deschutes1597

TIR/color video image pair showing a cool water seep along the right bank of Deschutes River (20.1°C) at river mile 33.0.

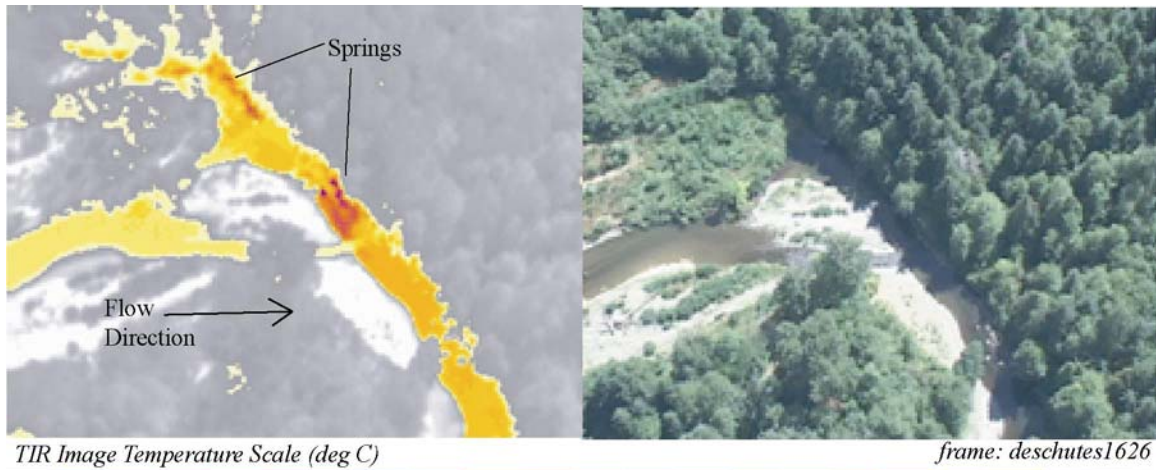
TIR/color video image pair showing two apparent springs (16.9°C) along the left bank of Deschutes River (20.1°C) at river mile 33.7. Radiant water temperatures decreased by $\approx 1.5^{\circ}\text{C}$ immediately downstream of this location.

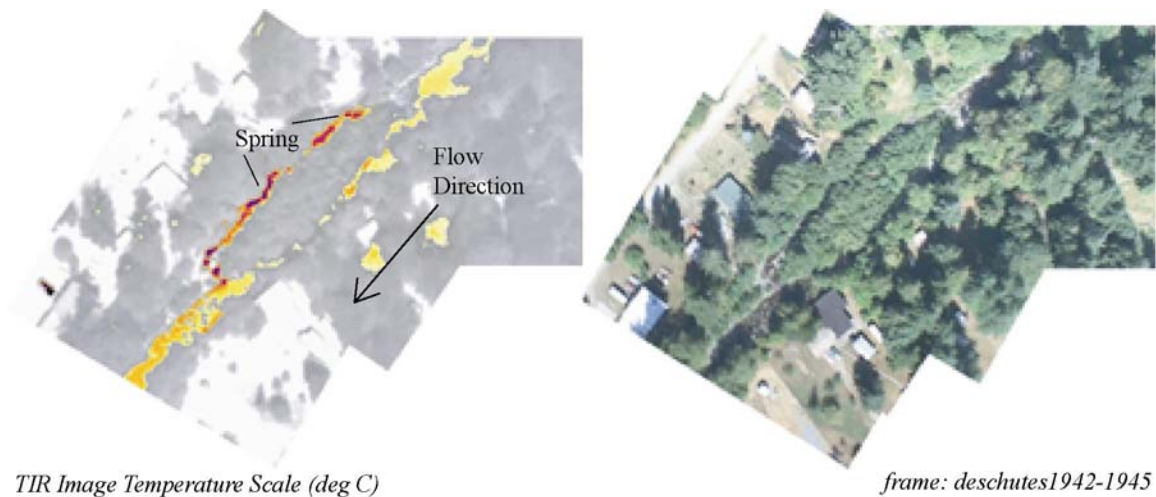
TIR/color video image pair showing a spring (13.7°C) along the right bank of Deschutes River (20.5°C) at river mile 38.5.
